# DDAS Accident Report

BAC INCIDENT REPORT 009/2007

### **INVESTIGATION REPORT ON A MZD 2 SUB-MUNITION AT CBU 829, Area 2 Ayta Ash Shaab on the 5th May 2007**

The Incident occurred in Area 2 (CBU 829), UTM 719524-664828 on the 5th May 2007, on a Completed Site where one MZD 2 Sub-Munition was located when an access road was being constructed.

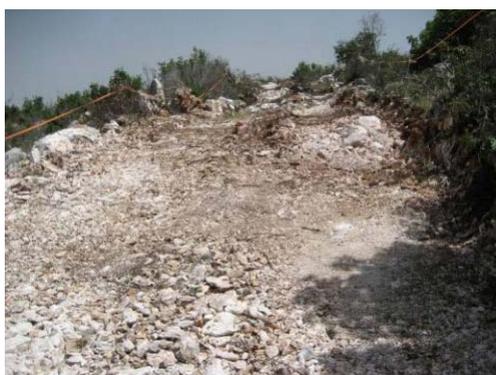
The accident site

- The land area in which the MZD 2 was located had been developed to allow the construction of an access road.
- A significant amount of earth and rocks had been relocated for other area to form the road.

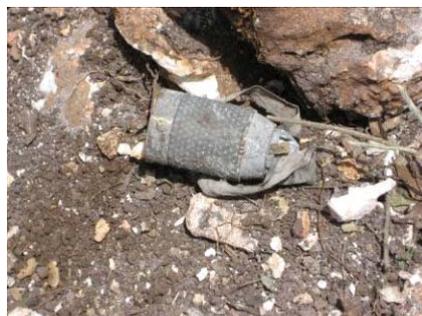
The MZ-2 submunition in-situ

- CBU 829 was previously surface cleared as part of a task dossier 2-007, and included CBUs 830 and 604, issued by the MACC SL to [Demining group].
- The location of the submunitions was identified as in an area that clearance had taken place.
- The MZD 2 was located at ground level, was in good condition, free of dirt and no damage was seen (see attached photos).
- An un-cleared area remains which may have MZD 2 located inside.
- The land owner wished to have the un-cleared area searched.
- It is unlikely that the MZD 2 sub-munitions would have been positioned in the location with little damage, free of spoil and completely above or on the surface given the amount of earthworks that was undertaken in the immediate and exact location of the MZD 2.

The primary cause of this Missed mine/device incident is listed as *Inadequate survey* because the area had been subjected to a surface search when it should have been sub-surface searched. The decision to conduct superficial surface search in areas where agricultural and construction activity would take place was the responsibility of the MACC SL, the same body

- CLOs to continue to warn local residence of areas have been cleared and the remaining un-cleared areas present a continued danger.
- Appropriate warning signs are erected in areas where there are un-cleared areas.
- Identify the un-cleared areas for future clearance priorities.
