# DDAS Accident Report

<b>Report date:</b> 15/07/2011	<b>Accident number:</b> 765
<b>Accident time:</b> 12:15	<b>Accident Date:</b> 03/12/2009
<b>Where it occurred:</b> AF0308/01635/5324, Qala-e-Ahmad jan village, Bagram District, Parwan Province	<b>Country:</b> Afghanistan
<b>Primary cause:</b> Inadequate training (?)	<b>Secondary cause:</b> Victim inattention (?)
<b>Class:</b> Handling accident	<b>Date of main report:</b> 09/12/2009
<b>ID original source:</b> None	<b>Name of source:</b> Demining group
<b>Organisation:</b> [Name removed]	
<b>Mine/device:</b> VOG-17, 30mm rifle grenade	<b>Ground condition:</b> soft wet
<b>Date record created:</b>	<b>Date last modified:</b> 15/07/2011
<b>No of victims:</b> 1	<b>No of documents:</b> 1

Detailed Demining Incident Report

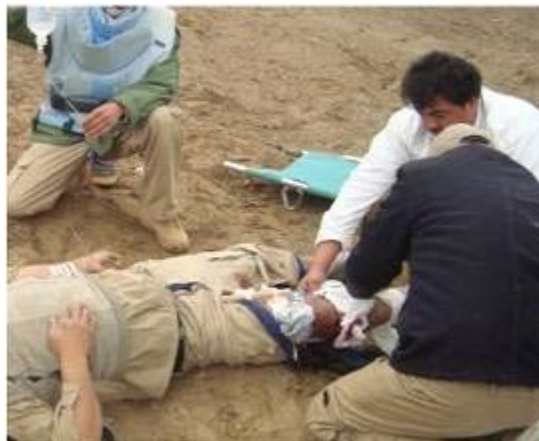
The patient has direct blast injuries below the knee on the right leg.

Bad Fractures, (Shattered) of the Tibia and Fibula bones.

[The Victim being treated in the field.]
