# DDAS Accident Report

## **Board of Inquiry Report**

[Demining group], Libya (Daphniya)  
Fatal Accident - 03 March 2012

Report date: 12 March 2012

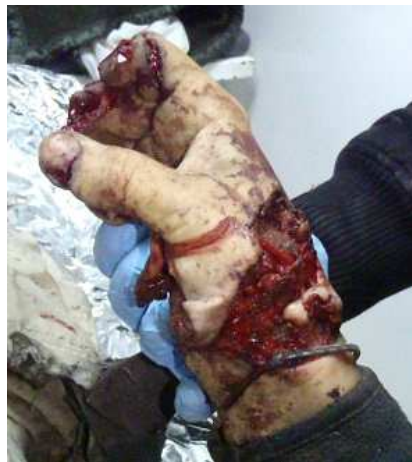
There was a massive traumatic wound to the front left quadrant of the head (M34 and M35); there were no burns or charring. Medical opinion is that this was the cause of death and that life would have expired instantaneously. The injury displays the typical indications of fragmentation injury. Experience of the Board of Inquiry members on past accident investigations suggests that this could possibly be due to the Misnay-Schardin plate being projected at high velocity (4000 – 5000 m/s) from a Type 84 mine; the size of the wound would be conducive with an explosively formed projectile (EFP) from a 118mm diameter warhead. But another source of high velocity fragmentation certainly cannot be excluded on the limited evidence available.

The fingers of the right hand were removed by traumatic amputation (M22); this injury is consistent with high velocity fragmentation damage. The remainder of the right hand and thumb was relatively undamaged (M22). There were no burns or charring to the right hand. The left hand was undamaged (M21).

There was significant blast damage, burning and charring to the lower right leg (M18), suggesting that this was very close to a seat of the explosion on, or just above, the ground. The right arm had suffered high velocity fragmentation injuries just above the elbow (M26).

There were numerous, low velocity fragmentation impacts to the body on the right hand side (M25).

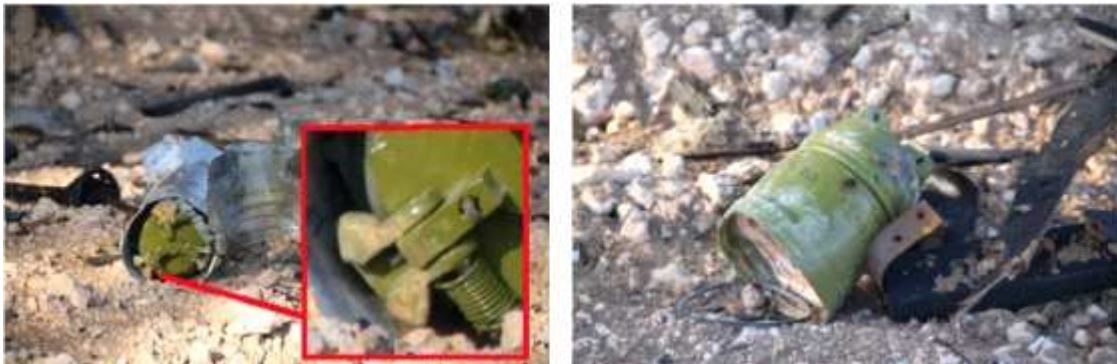
Armed Type 84 mine, still in the broken carrier. condition.

Type 84 mine in unknown, but possibly armed,

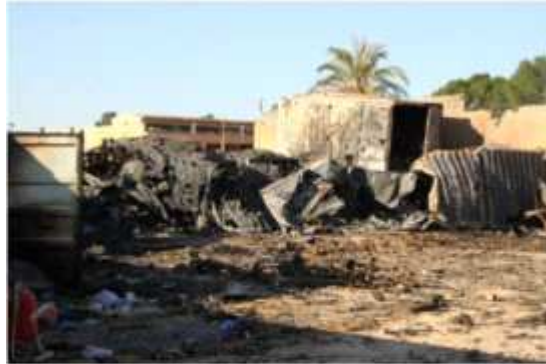
K73 03/03/12 - 09:22  
View through the hole in the wall towards the destroyed container area. This is the final picture found on the SD Card.

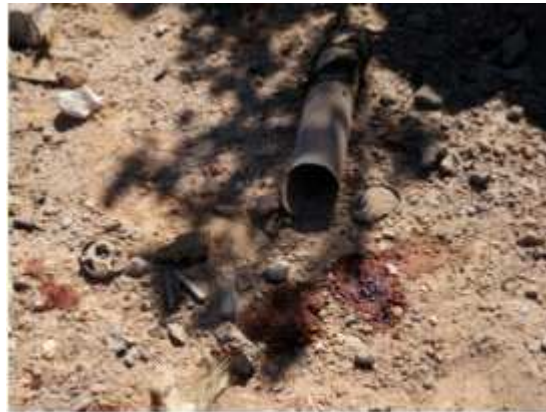
S10 03/03/12  
Site of the accident with Leatherman tool and remains of detonated Type 84 mines.

[The investigators noted that the Leatherman was with the bloodstained remains of the detonated mines but did not mention it again.]

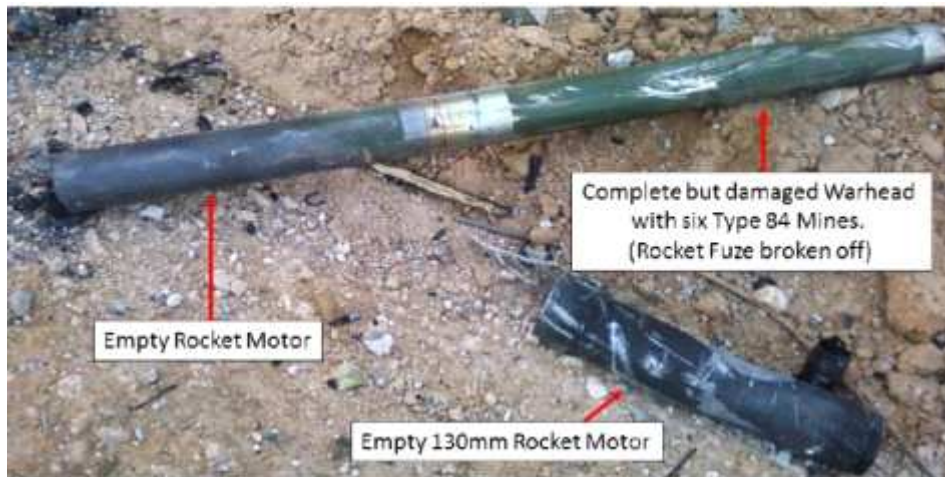
It is the opinion of the Board that the ammunition involved in this accident was a damaged Chinese manufactured 122-15 ATML Rocket containing 6 x Type 84 Scatterable Anti-Tank Mines. It is also the technical opinion of the Board that at least one, or more, of these mines detonated.

Damaged Chinese 122-15 ATML Rocket suspected to be cause of explosions. The lower right part is an empty 130mm rocket motor, which was accelerated to the opposite wall.
