# DDAS Accident Report

<b>Report date:</b> 12/07/2013	<b>Accident number:</b> 796
<b>Accident time:</b> 10:02	<b>Accident Date:</b> 04/12/2011
<b>Where it occurred:</b> Henaya Military Compound. 9km from Adjabiya	<b>Country:</b> Libya
<b>Primary cause:</b> Victim inattention (?)	<b>Secondary cause:</b> Management/control inadequacy (?)
<b>Class:</b> Handling accident	<b>Date of main report:</b> 05/12/2011
<b>ID original source:</b> None	<b>Name of source:</b> Demining group
<b>Organisation:</b> [Name removed]	
<b>Mine/device:</b> Fuze	<b>Ground condition:</b> demolition site (explosives)
<b>Date record created:</b>	<b>Date last modified:</b> 12/07/2013
<b>No of victims:</b> 3	<b>No of documents:</b> 1

### Internal Demining Group Accident Report

BAC Task N° 01/11/2011. AJDABIYA/ Henaya Military Compound

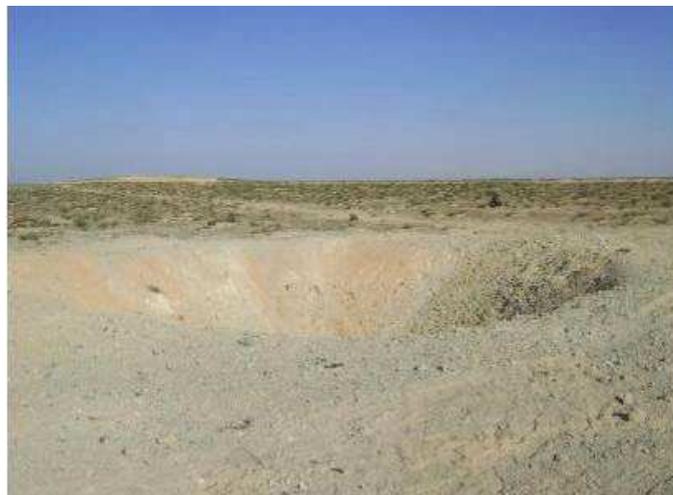
Demolition pit in HYNA area, 9 km East from Ajdabiya

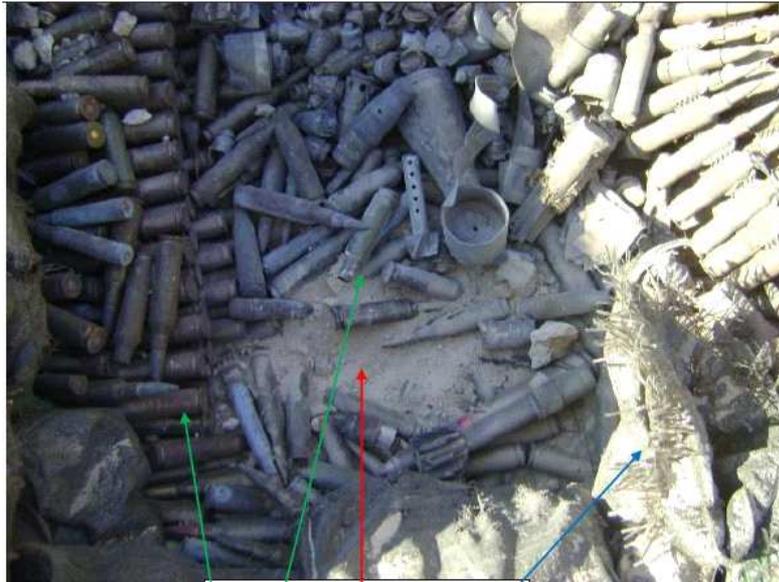
Detonation point  
 Sand bag damaged by the detonation

14,5 mm and parts of ERW kicked and removed out the sand bag by the detonation

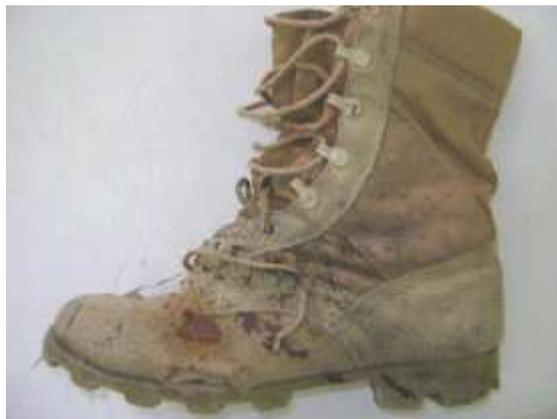
Right shoe. No evidence of a detonation under the shoe. Evidence of fragmentation hitting this part of the foot.
