DDAS Accident Report

Report date: 29/12/2013	Accident number: 802
Accident time: 08:55	Accident Date: 13/04/2011
Where it occurred: IMCT4 NR-928 Rasai, Kassala State	Country: Sudan
Primary cause: Field control inadequacy (?)	Secondary cause: Management/control inadequacy (?)
Class: Missed-mine accident	Date of main report: 14/04/2011
ID original source: None	Name of source: [Removed]
Organisation: [Name removed]	
Mine/device: PRB-M3 AT blast	Ground condition: dry/dusty, hard, metal fragments
Date record created:	Date last modified: 29/12/2013
No of victims: 1	No of documents: 1

Mine/uxo accident and incident detailed investigation report

IMCT4 Task ID: NR-928 Rasai, Kassala State

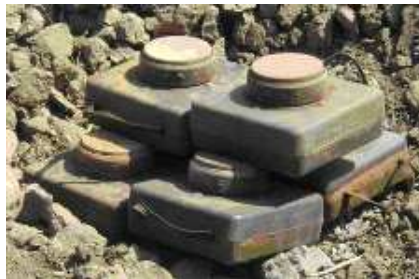
PRB-M3 (Belgium) A/T blast mine was involved in the accident.

Explosive Content: 6kg of Triallene with a hexolite booster

Operating pressure: 250kg

The PRB M3 is difficult to detect using metal detectors in field conditions where the ground has high metal content or fragmentation is present. In good conditions such as sand the PRB-
