DDAS Accident Report

Report date: 13/08/2016	Accident number: 806
Accident time: 08:51	Accident Date: 06/06/2015
Where it occurred: MF2, Border post 7, Khoshima, Shoh Village, Qubodiyon District, Khatlon Region	Country: Tajikistan
Primary cause: Unavoidable (?)	Secondary cause: Management/control inadequacy (?)
Class: Excavation accident	Date of main report: 10/06/2015
ID original source:	Name of source: TNMAC
Organisation: [Name removed]	Ground condition: dry/dusty; hard
Mine/device: PMN AP blast	Date last modified: 13/08/2016
Date record created:	No of documents: 2
No of victims: 1

Internal investigation report

Internal Investigation Report on mine accident in mine field-2 Khoshima, Qubodiyon Distruct, on 06 June 2015. The investigation was conducted by the [Demining group] Head of Operations [Name removed] and Technical Operational Adviser [Name removed].

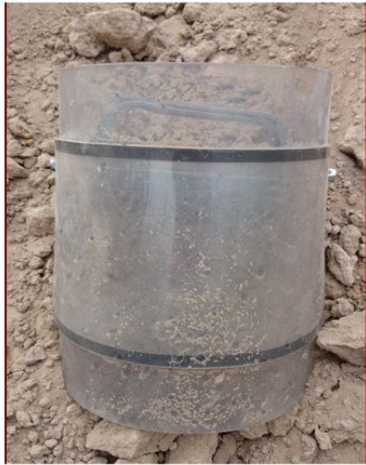
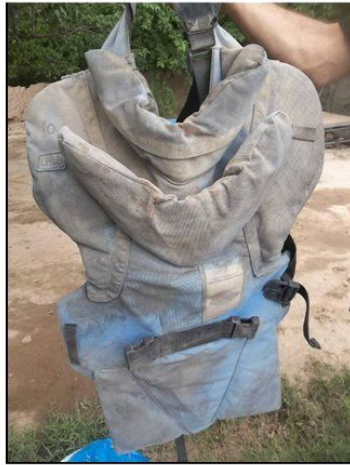
- Protection Visor: at the time of the accident filled with dust and soil.
- Uniform protection: at the time of the explosion was covered with black sand and blood. [See pictures below.]
- Trousers: after the explosion was torn.

[Visor showing a light mud spray and water droplets, but no damage. Frontal armour showing mud on right thigh and all over upper chest.]

The unrecorded (but photographed) damage to the Victim’s eye (which appears “normal” in his ID card photograph) may have been caused by sand sucked into the post-blast low-pressure area (a common occurrence) and so does not provide evidence that the visor was not worn before the blast. However, the injury to chin and mouth could not have been inflicted with the visor worn correctly unless the visor had split into separate parts. The visor was undamaged. These facts make it safe to infer that the visor was not worn or not worn in a down position at the time of the accident. The internal investigators appear to have been concealing the breach of SOPs involved in not wearing the visor correctly.

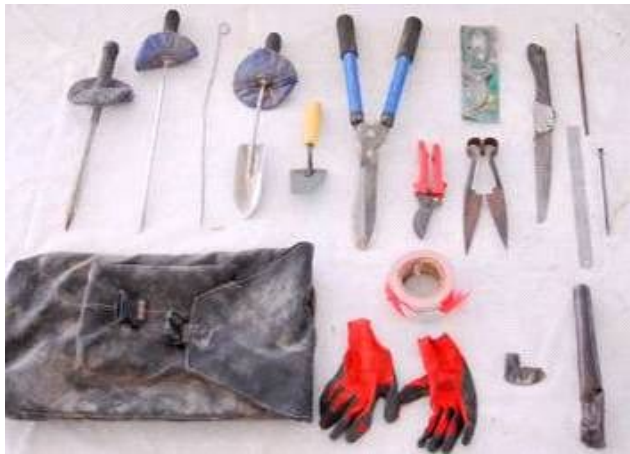
Demining equipment for excavation [Picture included does not show the short tool used at the time of the accident.]

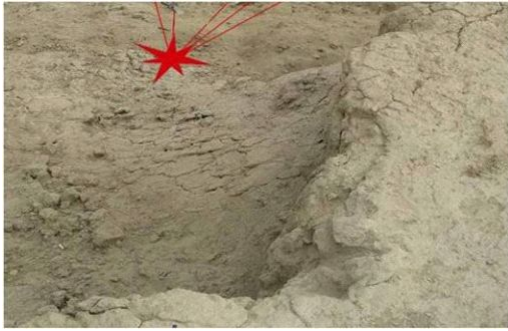
The place of the accident

The primary cause of this accident is listed as a “*Unavoidable*” because the investigators thought it likely that loose but heavy material from higher up the slope fell as the deminer was working, and this detonated the mine. This could have occurred. The secondary cause is listed as a “*Management Control Inadequacy*” because the senior demining group staff who investigated the accident were either attempting to conceal a field management failure or were entirely ignorant of the properties of a protective blast visor. The blast visor is permanently curved in one plane so that it wraps around the face. To curve in the opposite plane it would have to split. In a blast event, its existing curve may flatten out slightly and spring back, so demonstrating the elastic properties of polycarbonate, but it cannot bend backwards in the middle without splitting (which it can only do if enough force is applied – a force far greater than the force of an AP blast mine detonation at 60 cm). To have struck the Victim’s mouth and lips with a force hard enough to remove teeth the visor would have had to have flattened and crushed the wearer’s nose further back than his teeth, which it did not (and has never done in any recorded accident).

- During full excavation in the soft ground the using of the prodder tool is not recommended.
- Before using shovel, the ground should be checked with the detector.

- After destruction of the mines and UXO, the team and section leader should check the place of the destruction.
- This minefield presents challenges to the operation of the de-miners and has a very high risk. It is requested from TMAC use other mine clearance operations, probably mechanical.

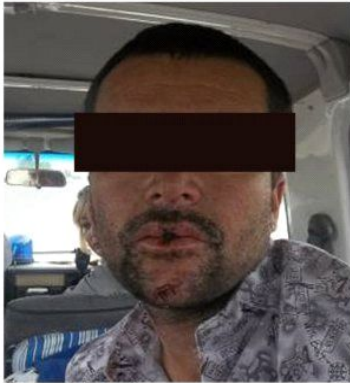
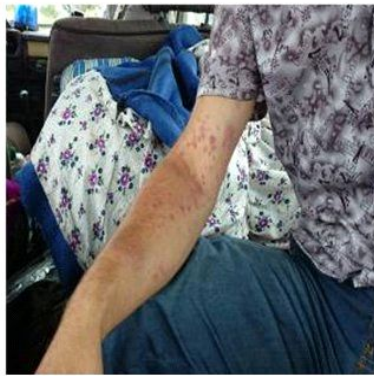
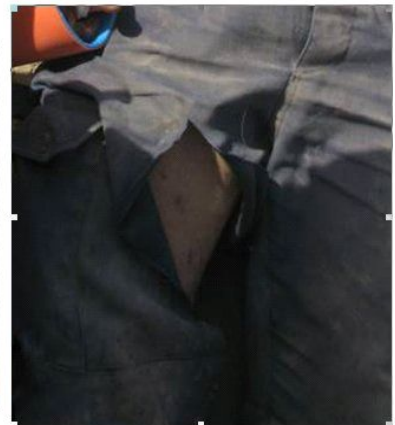
- Small wound on the lips.
- A small wound on the bottom lips.
- Small wound under his chin.
- Sores get small pieces.
- Three front tooth broken.
- Light concussion
- [A possible lung injury is reported in the statements. Eye, arm and leg injury is shown in the photographs.]

Injured picture of [The victim]. [Picture shows left eye slightly puffed and red, lips and chin both split. No damage at all to nose. Other pictures show light fragmentation on right arm from wrist extending over elbow and upper right thigh.]

From the photographic evidence, it is clear that the Victim’s small and short trowel (called a shovel in the report) was damaged. It is likely that the tool was in his hand at the time of the accident and thrown backwards by the blast. The back of the flat blade may have struck the deminer on the chin and mouth, knocking out his teeth. The mud stains on the body armour show that the force of the blast appears to have struck his upper body and the investigators report him having been thrown back six metres (a very unusual distance). If this is so, it implies that he was leaning over the top of the explosion but this may not indicate that he was working incorrectly if the blast were caused by a heavy fall of material from above.

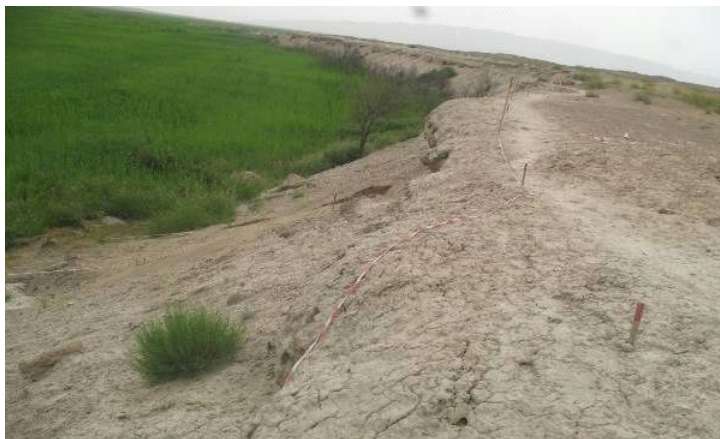
This minefield is situated near observation border point #7 Khoshima. One part of this minefield is laid on an earth ridge of high ground and the lower part is in a reedy area. Due to the location of mines which lie on the crumbling edge of the ridge, the mines have been covered by soil. The depth of these mines is 50-80 cm. For this reason we applied a full excavation method until finding the real minefield area. According to submitted reports from the group in May 2014, in one working day 48.5 m² of land was cleared. Due to this reason the work was running very slow in that minefield.

Minefield area on the slippage.

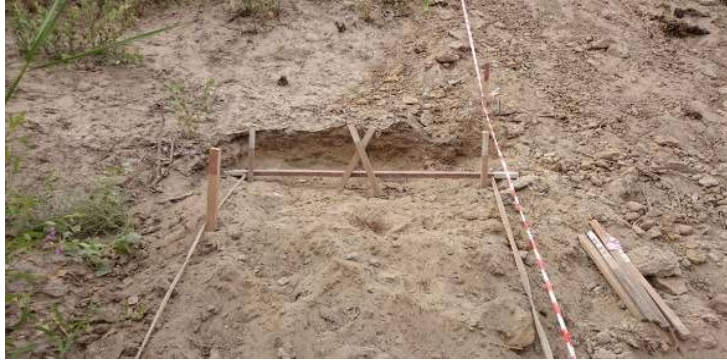
Marking used on the minefield.
