# DDAS Accident Report

### Commission's Report on investigation of the mine accident on the road passes of Khaburobod Darvoz District

10 September 2008, Dushanbe

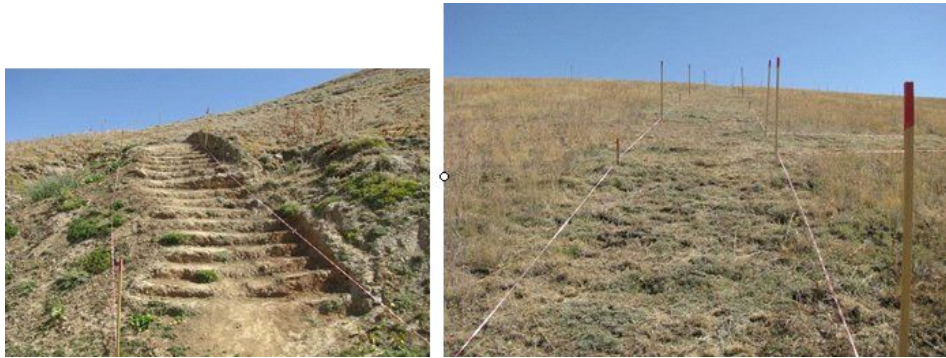
The mine accident area was intended for use as pasture. A small military base existed in this area before. The minefield is located around the mentioned military base and the clearance field which mine accident happened was rough (bumpy) land.

[The photographs show the mined area, including steep access in which steps had been cut.]
