DDAS Accident Report

Accident details

Report date: 11/04/2019	Accident number: 819
Accident time: Not recorded	Accident Date: 20/01/2019
Where it occurred: MASAM compound, Marib City, Marib governate	Country: Yemen
Primary cause: Field control inadequacy (?)	Secondary cause: Inadequate training (?)
Class: Handling accident	Date of main report: 21/01/2019
ID original source:	Name of source: Press/social media
Organisation: [Name removed]	Ground condition: hard; residential/urban
Mine/device: AT (unrecorded)	Date last modified: 11/04/2019
Date record created:	No of documents: 1
No of victims: 5

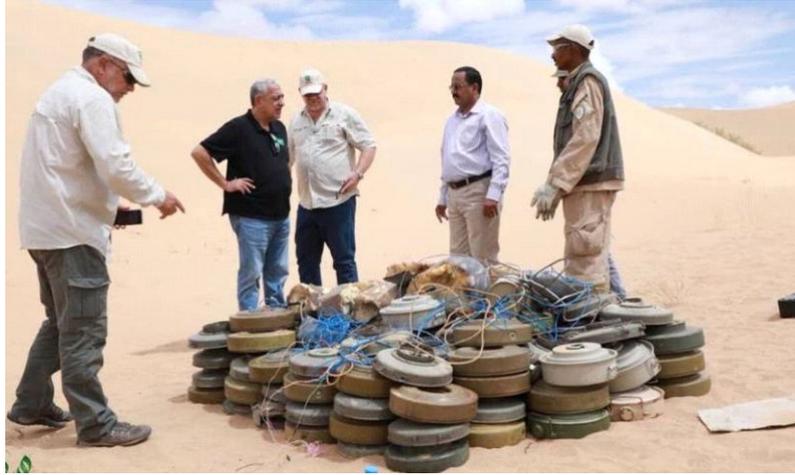
[This photograph apparently shows preparations for a previous demolition. Some mines shown may still be fuzed. The pile appears to have IEDs or IED components on top. No PPE is being worn.]

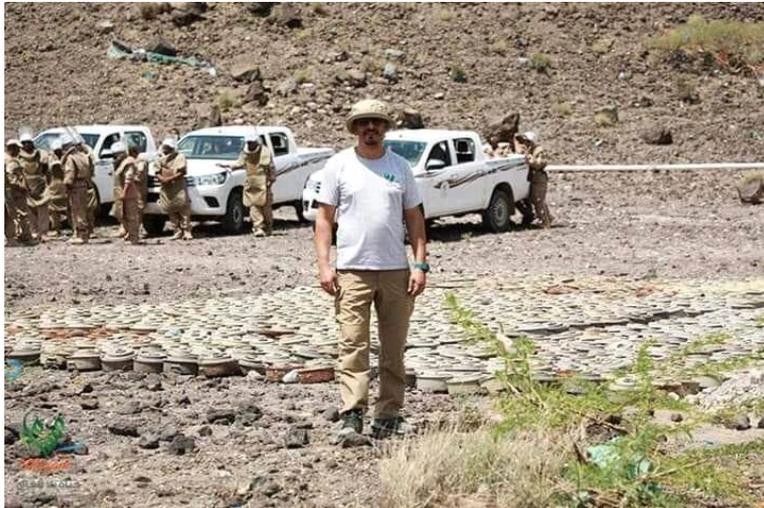
[This picture shows [Victim no.1] in front of hundreds of recovered AT mines, all of which would have been transported in the back of the pick-up trucks behind. As is common, the supervisor is proudly photographed not wearing any PPE.]

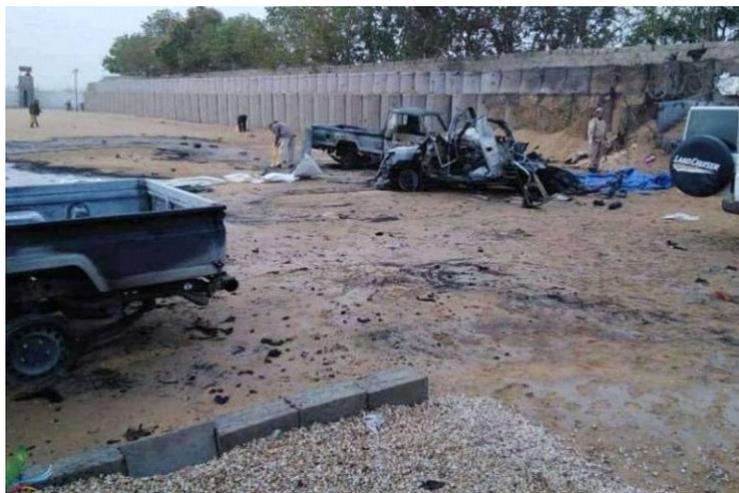
[This picture was taken after the pickup truck top centre has exploded. The blast damage indicates that it occurred in the back of the truck. Two other trucks are wrecked. People

anywhere close by would have been killed by the blast and fragmentation from the metal mine casings and the truck. The blue tarpaulin may conceal body parts.]

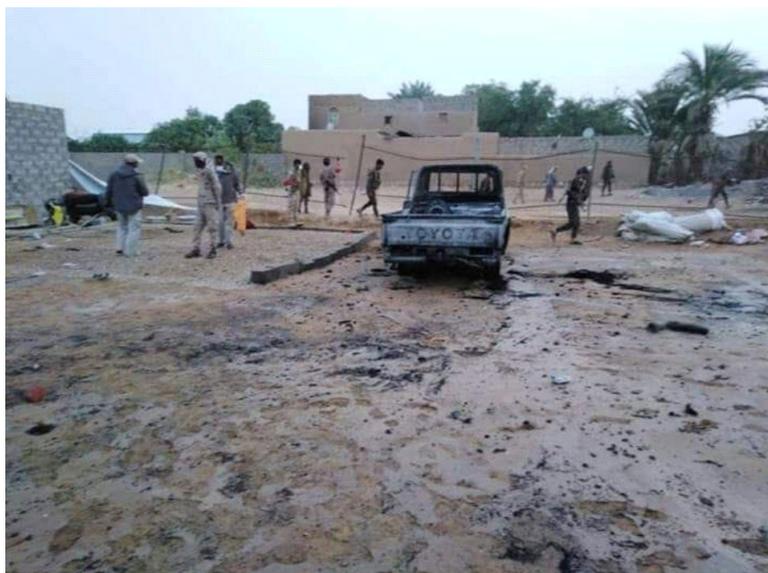
[Another view shows a third burned out pickup truck and seems to confirm that this happened inside a compound, not in transit.]

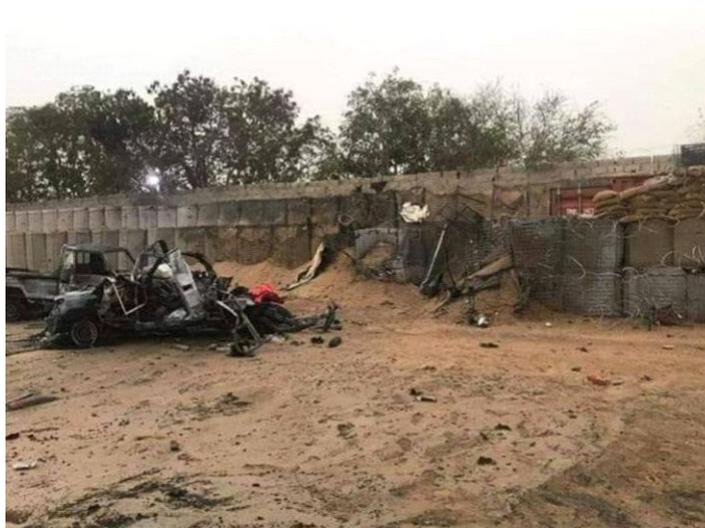
[The storage area for explosives may be behind the protected door on the right.]

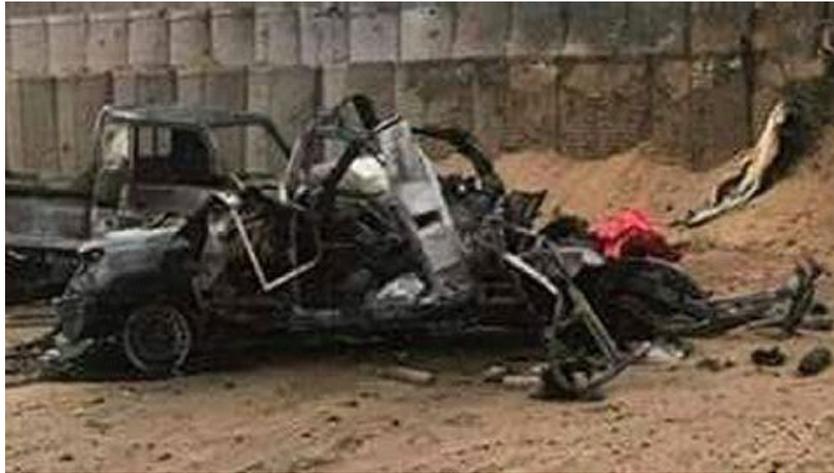
[A major detonation occurred in the back of this truck, destroying the second pickup truck close by. A third pickup truck some 25 metres away caught fire and burned out, which implies a very significant blast or may imply that other munitions, possibly including incendiary materials, were being transported along with the mines.]
