# DDAS Accident Report

<b>Report date:</b> 27/03/2017	<b>Accident number:</b> 822
<b>Accident time:</b> 15:00	<b>Accident Date:</b> 13/01/2017
<b>Where it occurred:</b> KSDT Area 002. Karen State, Myanmar	<b>Country:</b> Myanmar
<b>Primary cause:</b> Other (?)	<b>Secondary cause:</b> Other (?)
<b>Class:</b> Excavation accident	<b>Date of main report:</b> 14/03/2017
<b>ID original source:</b> KMAC_1	<b>Name of source:</b> AVS
<b>Organisation:</b> [Name removed]	<b>Ground condition:</b> dense vegetation, rocks/stones, steep slope
<b>Mine/device:</b> K_improvised_mine-IED	<b>Date last modified:</b> 27/03/2017
<b>Date record created:</b>	<b>No of documents:</b> 1
<b>No of victims:</b> 1

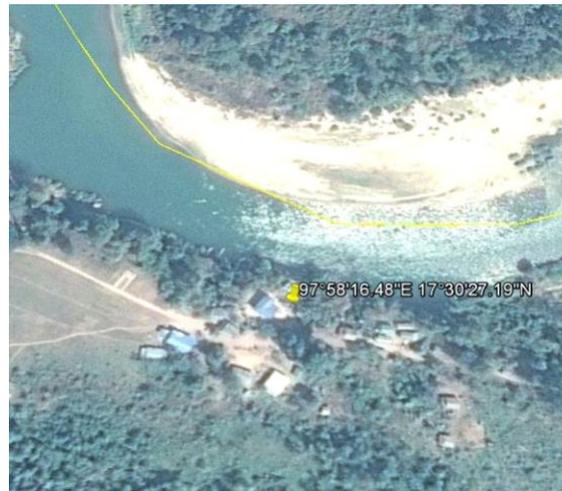
The picture shows the village where the accident occurred.
