# DDAS Accident Report

<b>Report date:</b> 19/04/2006	<b>Accident number:</b> 54
<b>Accident time:</b> 10:30	<b>Accident Date:</b> 21/11/1997
<b>Where it occurred:</b> Road from Luena to Lucesse	<b>Country:</b> Angola
<b>Primary cause:</b> Unavoidable (?)	<b>Secondary cause:</b> Management/control inadequacy (?)
<b>Class:</b> Detection accident	<b>Date of main report:</b> 05/12/1997
<b>ID original source:</b> JM/PGC/GP/MB	<b>Name of source:</b> INAROOE
<b>Organisation:</b> [Name removed]	
<b>Mine/device:</b> not known	<b>Ground condition:</b> clay route/path sandy
<b>Date record created:</b> 23/01/2004	<b>Date last modified:</b> 23/01/2004
<b>No of victims:</b> 2	<b>No of documents:</b> 2

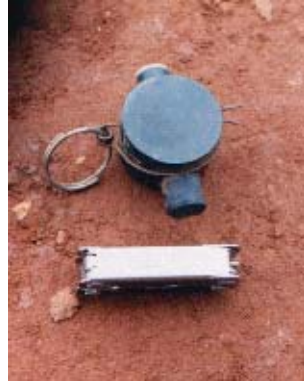
Given that pressure switches have been found that could be initiated by simply changing weight distribution without moving a foot, this seems most likely to have been the device used – unless the deminer group was the target of a command detonation.

The picture above shows an RSA "PRANK" or "toe-popper" pressure switch found in Angola. It is attached to det-cord that is then wrapped around an improvised charge or mine.

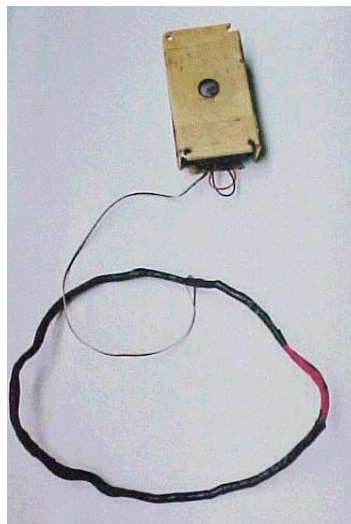
The picture above shows the switch sent for analysis to Ebinger. The unit was manufactured in South Africa.

Named the "Sweep Spy", the device is designed to be activated by the presence of the "Soviet stick" detector used by the Cubans during the early years of the Angolan conflict. It also incorporates a "light-sensitive eye" as an anti-disturbance device.

The electronics and battery are "potted" in resin, so replacing a battery is practically impossible. The original battery was intended to remain operative for 12 months after the device was activated.

The device fires a detonator electronically – the detonator being attached to two wires (tucked under the device in the picture).

It was claimed that only eight "Sweep-Spy" devices were manufactured, and the makers believe that it is extremely unlikely that any would be functional now.
