DDAS Accident Report

Report date: 19/04/2006	Accident number: 94
Accident time: not recorded	Accident Date: 01/06/1997
Where it occurred: Qala Muslim Village, Ward 7, Kabul city	Country: Afghanistan
Primary cause: Field control inadequacy (?)	Secondary cause: Inadequate equipment (?)
Class: Excavation accident	Date of main report: [No date recorded]
ID original source: none	Name of source: MAPA/UNOCHA
Organisation: [Name removed]	
Mine/device: PMN AP blast	Ground condition: hard rocks/stones
Date record created: 24/01/2004	Date last modified: 24/01/2004
No of victims: 1	No of documents: 1

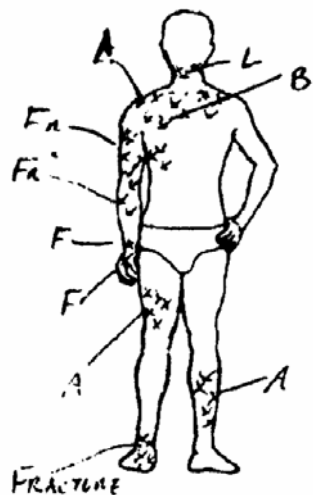
The victim's injuries were summarised as: fractured fingers on right hand, fragments on right arm, legs, chin, left hand and chest.

A medic's sketch (reproduced below) showed multiple fragments and abrasions to his chest and right arm, right thigh and left shin and a fractured ankle.
