DDAS Accident Report

| Where it occurred: Plowshare minefield, Mukumbura | Country: Zimbabwe |
| Mine/device: R2M2 AP blast | Ground condition: woodland (bush) |

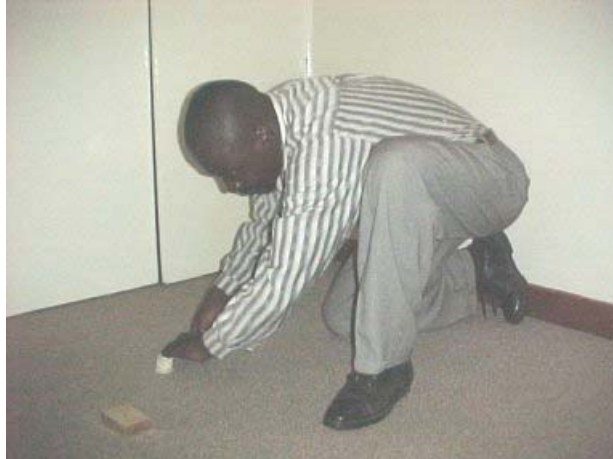
The victim was interviewed on 10th March 1999 in Harare and photographed reproducing his working position. He said that the accident occurred while he was prodding.
