DDAS Accident Report

Report date: 19/05/2006	Accident number: 369
Accident time: not recorded	Accident Date: 14/02/1992
Where it occurred: Oupale, Xangongo, Cunene Province	Country: Angola
Primary cause: Field control inadequacy (?)	Secondary cause: Inadequate equipment (?)
Class: Excavation accident	Date of main report: [None]
ID original source: none	Name of source: HE/HGK
Organisation: Name removed	
Mine/device: TM57 AT blast	Ground condition: agricultural (abandoned) bushes/scrub sparse trees
Date record created: 21/02/2004	Date last modified: 21/02/2004
No of victims: 1	No of documents: 1

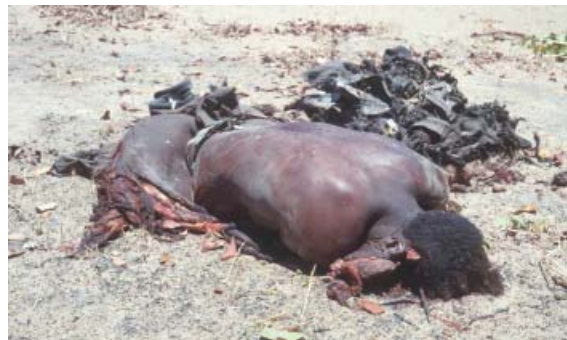
The Victim initiated a TM-57 anti-tank mine with his pickaxe. He was killed instantly (see photograph in Medical report). His body was thrown 15 meters from the seat of the explosion. Medical staff were on site immediately, but could do nothing to assist the victim.

The victim died immediately. See photograph in Medical report.

No formal medical report was made available. The following photograph shows the victim immediately after the accident.

Site managers immediately issued clear and unambiguous instructions that deminers working dangerously should be ordered to stop work immediately.
