# DDAS Accident Report

## **REPORT OF BOARD OF INQUIRY**

INTO DEMINING ACCIDENT AT SHULL MOUNTAIN ON 21 AUGUST 2006

Dushanbe 31 August 2006

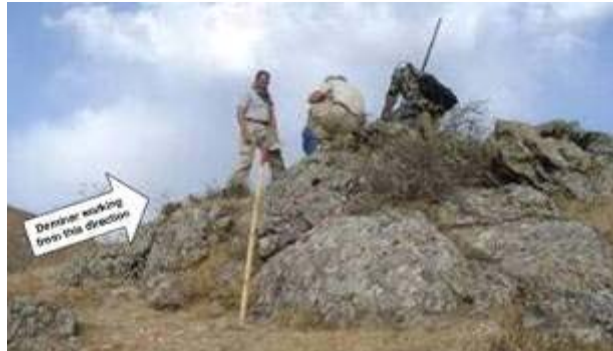
[The picture below shows the rocky outcrop where the accident occurred.]

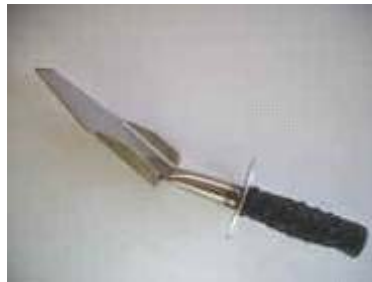
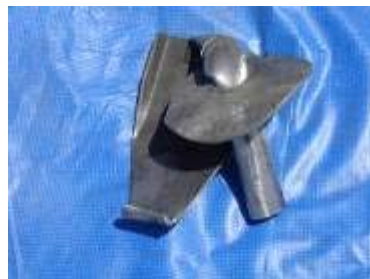
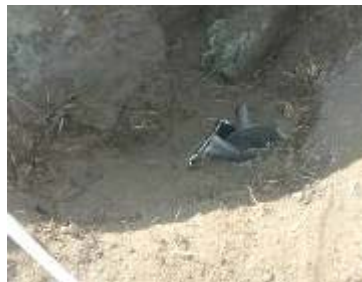
52. Prodder - A stainless steel prodder was found next to the crater and it was clear that, although ready for deployment, this tool was not in immediate use at the time when the mine detonated.
53. Pin hammer, normally used for driving wooden marker pickets into the ground. This was laid neatly on the ground, next to the manual prodder tool.
54. Trowel – A stainless steel, blast-resistant trowel, manufactured by LVP Technology of South Africa, (<http://www.lvptech.com/Main.htm>) was in the crater left by the blast of the mine. The trowel was severely damaged, the final 2cm of the point of the blade is rolled back on itself and the handle is bent completely over the blade.

[The trowel before and after the accident is shown below. This is sold as blast resistant because the material does not break. However, the length is not as recommended in IMAS, the metal handguard has broken and the handgrip has been removed in the blast.]

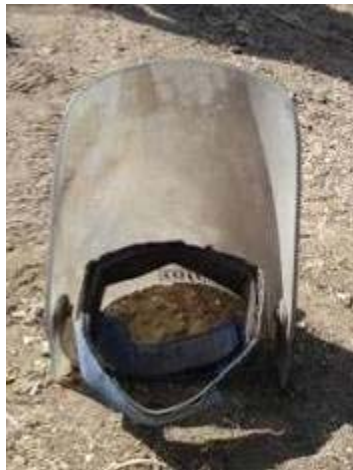
65. The blast resistant visor is the crux of this investigation. During the Board of Inquiry's time at the demining task site and the scene of the accident, a number of visors were observed by each member of the team. Some were in good condition, others were less so. If a visor is clear and clean and unmarked it is obviously easier to see through and there will obviously be less temptation for a deminer to lift his visor to attain a better view of his work or surroundings.

66. Protective facial visors are notoriously difficult to wear and deminers universally do not like to wear them. This is particularly the case in hot weather, when they can become fogged with condensation from the wearer's breath. When reasons for raising visors are given by deminers, they commonly make reference to a lack of optical clarity when looking through the visor. This may be blamed on light scratching, breath condensation, distracting optics (caused by reflections and refracted sunlight), airlessness and excessive heat. [The Victim's visor is shown below.]

67. There is sufficient damage inside the visor to suggest that it deflected environmental and mine-case fragmentation onto [the Victim's] face from the detonation of the PMN anti-personnel mine he was likely excavating at the time of the accident. From this it seems very likely that [the Victim] was using his trowel and excavating vertically over the mine with his visor at least partly raised.

- u) All personnel at all work sites should conform to all aspects of [International demining group]'s Standing Operational Procedures. Specifically, this should mean that, when they are working within hazardous areas, personnel deployed on mine clearance operations should wear PPE complete with visor in the fully down position to completely cover the wearer's face.

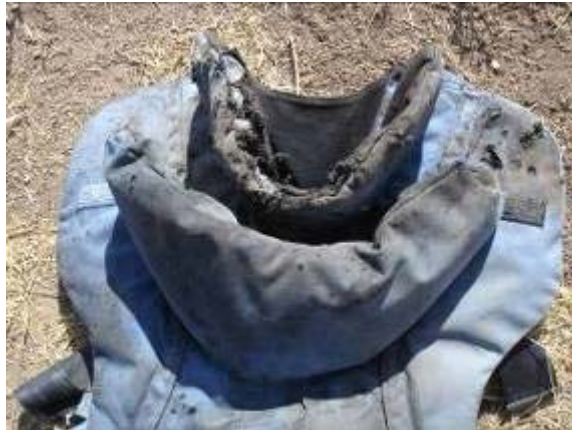
[Damage to the Victim's body armour makes it likely that a closed visor would have also sustained significant damage low down.]

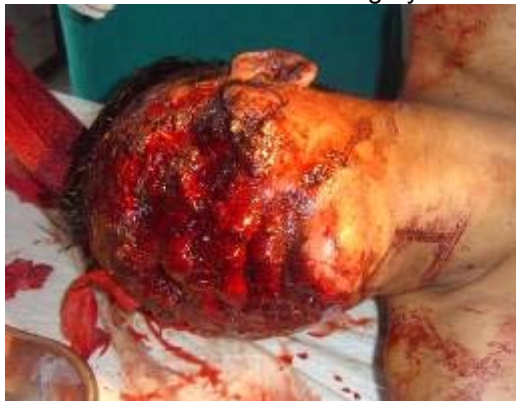
The pictures below show the Victim before and after surgery.

Photographs showed one leg bandaged top to bottom, the other peppered with small fragmentation wounds at the thigh. Both hands were bandaged and bloody with lacerations of the fingers.

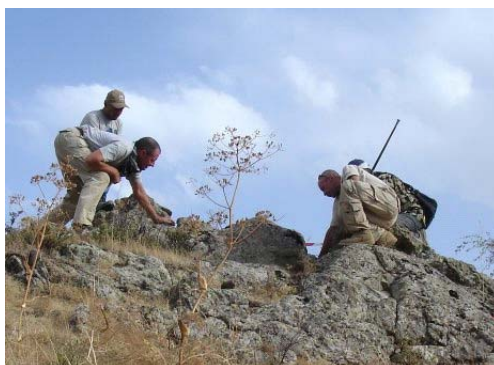
It is unfortunate that pictures of the accident investigation show International demining group expatriate investigators at the site wearing no PPE. This obviously sets a very bad example. They were inside a partly cleared minefield and – according to National standards and the demining group’s SOPs – should have been wearing PPE. The BoI investigators all wore PPE at the accident scene.

The International demining group investigators below are on the rocky outcrop where the accident occurred. The fact that they gave the picture to the BoI implies that they did not know that they were in breach of their own SOPs.
