DDAS Accident Report

Report date: 02/02/2008	Accident number: 500
Accident time: 11:07	Accident Date: 17/07/2007
Where it occurred: MF/ No 0009, Dasht-e-Chinar Village, Rusted District, Takhar Province	Country: Afghanistan
Primary cause: Field control inadequacy (?)	Secondary cause: Management/control inadequacy (?)
Class: Excavation accident	Date of main report: 19/07/2007
ID original source: OPS/ 03/ 01 - 45	Name of source: UNMACA
Organisation: [Name removed]	
Mine/device: PMN-2 AP blast	Ground condition: dry/dusty grass/grazing area hard metal fragments rocks/stones
Date record created:	Date last modified: 02/02/2008
No of victims: 1	No of documents: 2

Accident/Incident investigation report

Subject: Investigation Report and Lessons Learned – Demining Accident

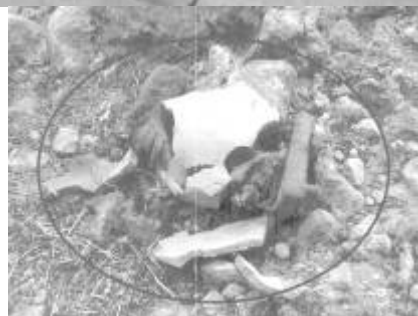
[The frontal apron and parts if the Visor helmet: damage is far too extensive for a normal AP blast.]

Description of damage to property: The helmet along with visor was completely destroyed. The protective jacket was seriously damaged. The deminer's uniform was also damaged.

There was no evidence of the helmet and PPE having been destroyed at the scene of the deminers work place. There was however evidence that indicated the helmet and PPE may have been destroyed approximately 7 metres away from the scene of the accident in a previously cleared area.

2. All staff are to be reminded that PPE shall be worn at ALL times once moving into the hazard area after leaving the administration area.
3. The Team and Section Leader of [National demining group] DT 01 shall be demoted immediately to Section Leader and Deminer respectively and re-employed into other teams.

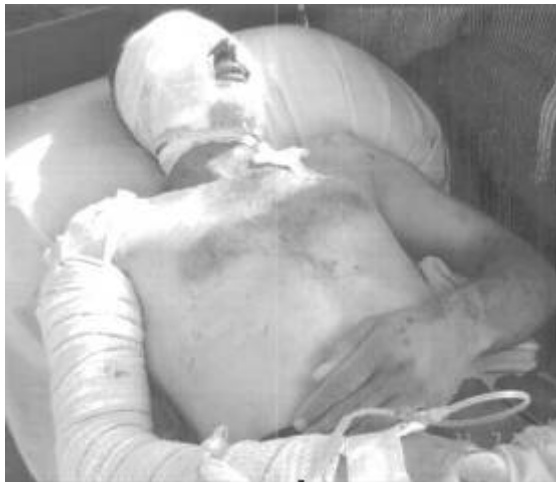
Injuries sustained: Loss eyesight (both sides), left arm. Other injuries: chest and upper limbs.

[The Victim in hospital.]

The injuries received by the deminer were not conducive to him wearing his helmet and PPE at the time of the accident as is required when ever inside a hazard area.
