DDAS Accident Report

Report date: 06/03/2011	Accident number: 669
Accident time: 06:50	Accident Date: 19/08/2009
Where it occurred: MF 411, Al Shajarah Village, Alramtha Province	Country: Jordan
Primary cause: Unavoidable (?)	Secondary cause: Unavoidable (?)
Class: Excavation accident	Date of main report: Not recorded
ID original source: None	Name of source: Demining group
Organisation: [Name removed]	
Mine/device: M14 AP blast	Ground condition: grass/grazing area
Date record created:	Date last modified: 06/03/2011
No of victims: 1	No of documents: 2

INCIDENT INVESTIGATION [Demining group] – MINE ACTION TEAM - JORDAN

TASK NAME AL SHAJARAH 2 (411), NORTH BORDER PROJECT

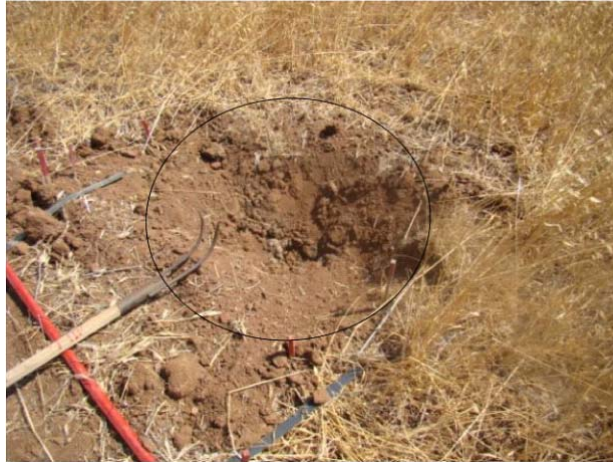
[Accident site]

Deminer Was Clearing the first 60 cm from the centre lane on a depth of 30 cm using the heavy RAKE after he done with the light rake , deminer hit the M14 mine on a depth of 35 cm by the heavy rake which initiate the mine. [The depth appears to be an error, and should perhaps be 15cm.]

17. Comments (include measurements of any crater resulting from the explosion): Crater
Depth: approx. 15 cm / Width: approx. 40 cm

Incident happened due to an individual mistake when he was trying to drag from the soil, he dragged the mine with a piece of solid soil that caused pressure on the plate and initiate the mine.
