# DDAS Accident Report

### **INCIDENT INVESTIGATION [Demining group] – MINE ACTION TEAM - JORDAN**

TASK NAME SABHA 8 (399), NORTH BORDER PROJECT, EAST SECTOR

MINEFIELD NO: - 399, MINEFIELD TASK ID: - E 399 SABHA 8

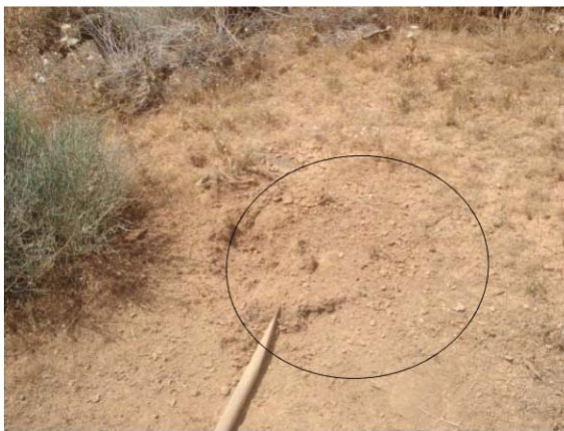
While the deminer try to recover one missing AP mine (M14) assigned for him by the team leader after grapping all the visible APs in the cluster and the central AT, the mine blasted 2.2 metres away from the deminer while searching the area with the heavy RAKE after pinpointing a signal using the metal detector.

17. Comments (include measurements of any crater resulting from the explosion): Crater Depth: approx. 15 cm / Width: approx. 40 cm

Yes, the accident happened while using the heavy rake and because of the existence of a buried stone which was hit by the rake and fell on the mine which made the accident.
