DDAS Accident Report

Report date: 17/05/2006	Accident number: 161
Accident time: 08:30	Accident Date: 05/10/1998
Where it occurred: Trapeing Phlong Commune, Ponhea Krek, Kampong Chan Province	Country: Cambodia
Primary cause: Unavoidable (?)	Secondary cause: Inadequate equipment (?)
Class: Excavation accident	Date of main report: 12/10/1998
ID original source: none	Name of source: CMAC
Organisation: Name removed	
Mine/device: M14 AP blast	Ground condition: bushes/scrub dry/dusty electromagnetic hidden root mat
Date record created: 14/02/2004	Date last modified: 29/02/2004
No of victims: 1	No of documents: 2

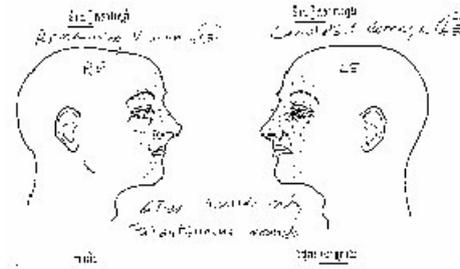
On 6th October a surgeon from a "Ophthalmologic Section" (hospital not stated) said that he had found "numerous very small holes on the eyeball".

On 7th October the Medical Officer was told by International Resources for the Improvement of Sight (IRIS) that the victim had microscopic holes on both eyeballs which could not be repaired.

On 8th October the DU4 Medical Officer himself tested the sight of the victim and found that he still had some vision and was able to identify colours, numbers and objects.
