DDAS Accident Report

A Board of Inquiry (1301) 03/01 2001 was convened as a result of a mine strike on a Hydrema flail being operated by [two NGO's together] on 29 Sep 01 in Shilalo minefield ER246.

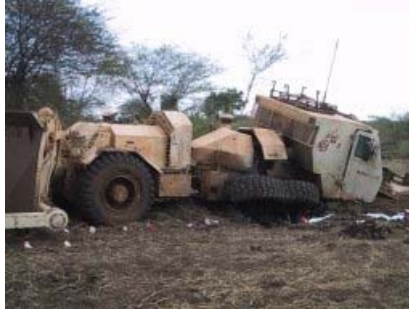
- j. The vehicle cab is not sufficiently protected against AT mines as shown by all the internal damage, the broken door and the injuries to the operator.

- a. The Hydrema flail should be suspended from operations in AT minefields in UNMEE AOR until safety modifications are done and the machine is retested and certified to be suitable for use.
