DDAS Accident Report

Accident details

The accident involved the "Mine Clearance Cultivator", a machine owned by the US government and under trial with [a demining NGO] in Southern Angola.

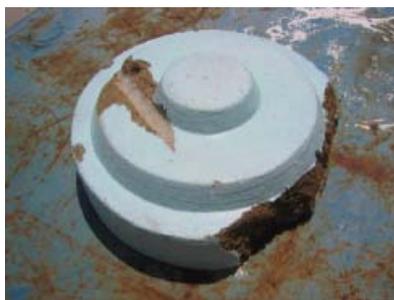
I found that the device had detonated on the left-hand side (facing forwards) of the MCC's cultivating attachment. It had apparently detonated above ground level and on top of the auger to the rear of the attachment, exploding as it passed to the side of the machine. Damage to that side of the auger and entire cultivating attachment was severe, with large parts separated. This means that the mine detonated on the T55 side of the MCC, and there was some evidence of sooting and light fragmentation damage to the side of the T55 tank. The tank was in poor condition and some damage may have been old. There was no evidence that either the tank or the MCC were physically lifted or moved sideways by the detonation.

The picture below show the auger damage.

The mine appeared to have initiated as it left the auger and so below or beyond the left-side upper support arm of the cultivator and alongside the auger-drive mechanism. This means that the detonation was confined on one side by the cultivator and on the other by the wrecked T55 tank. The T55 is embedded in the ground and has not moved (crusted earth around the wheels and rollers was unbroken). Reflection from the tank may have had the effect of intensifying the blast damage to the cultivator and auger mechanism.

The cultivating attachment is so severely damaged that it may not be economic to repair it.
