# DDAS Accident Report

<b>Report date:</b> 29/12/2007	<b>Accident number:</b> 451
<b>Accident time:</b> 10:55	<b>Accident Date:</b> 04/09/2006
<b>Where it occurred:</b> ME No-070719-013-021, All Khil village Jaji District, Paktya Province	<b>Country:</b> Afghanistan
<b>Primary cause:</b> Management/control inadequacy (?)	<b>Secondary cause:</b> Unavoidable (?)
<b>Class:</b> Excavation accident	<b>Date of main report:</b> 20/09/2006
<b>ID original source:</b> SE-05	<b>Name of source:</b> UNMACA
<b>Organisation:</b> [Name removed]	
<b>Mine/device:</b> PMN AP blast	<b>Ground condition:</b> dry/dusty hard rocks/stones
<b>Date record created:</b> 28/12/2007	<b>Date last modified:</b> 29/12/2007
<b>No of victims:</b> 1	<b>No of documents:</b> 2

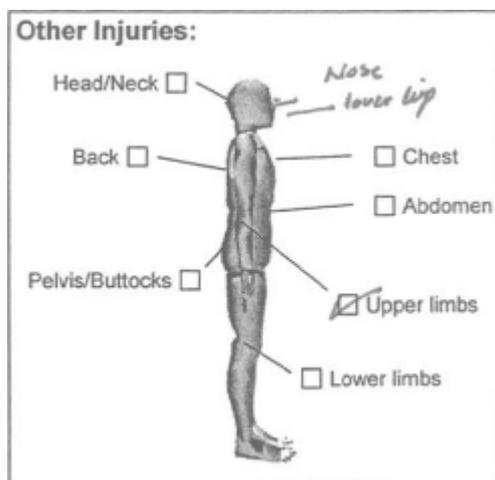
### Medical report

The IMSMA report shows injuries to both hands and forearms, and to the nose and lower lip. It records:

1. pass IV cannula
2. susigay
3. Start IV Hesid Ringer
4. Wash of wounds
5. Cleaning of wounds with antiseptic.
6. Dressing

8. dressing with burns after op. Cleaning of wounds with [illegible] hydrogen peroxide.

9. Use of splint close of ulna fracture.
