DDAS Accident Report

Report date: 30/12/2007	Accident number: 452
Accident time: 07:45	Accident Date: 24/07/2006
Where it occurred: MF No-070719-013-021, Ali khil village, Jaji District, Paktya Province	Country: Afghanistan
Primary cause: Unavoidable (?)	Secondary cause: Inadequate equipment (?)
Class: Excavation accident	Date of main report: 24/07/2006
ID original source: QM.2.4.03/139.006	Name of source: UNMACA
Organisation: [Name removed]	
Mine/device: PMN AP blast	Ground condition: dry/dusty hard metal fragments rocks/stones
Date record created: 30/12/2007	Date last modified: 30/12/2007
No of victims: 1	No of documents: 2

SUBJECT: ATC DEMINING ACCIDENT ID NO E-04

Initial Demining Investigation Report

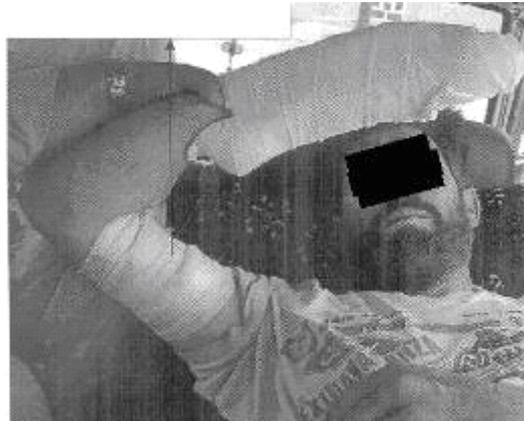
After gotten the first aid the casualty is transferred to Jaji Hospital. The General condition is good only right hand index finger including palm of right hand has gotten injured

IMSMA record: Rt: polex and index finger injuries. Right hand injury. Anti brachium multiple injuries. Digitus medius. Right arm injury and left hand injury.

1. Right arm (upper) injury.
2. Assessment of trauma and ABC
3. Bleeding control tie tourniquet heavy bleeding
4. Pass IV canulla to keep veins open
5. Analgesic given uj sosegan 30 ml IV
6. Use of splent
