# DDAS Accident Report

## **Board of Inquiry Report**

[Demining group], Libya (Daphniya)  
Fatal Accident - 03 March 2012

Report date: 12 March 2012

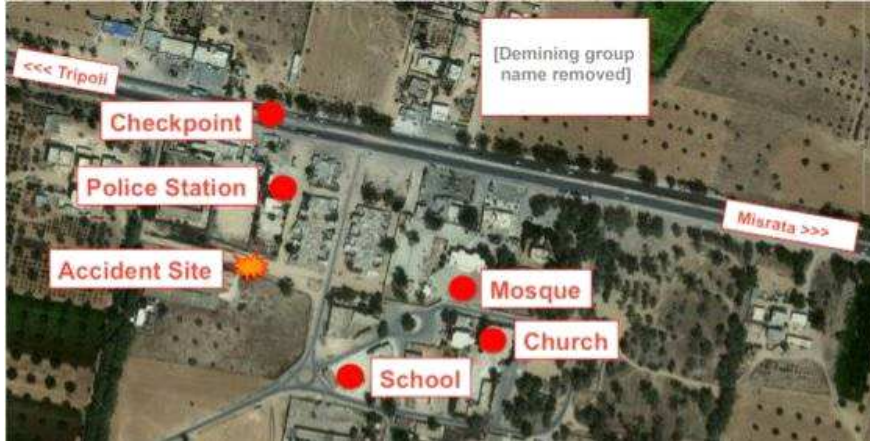
Image 1: Overview of Daphniya Area

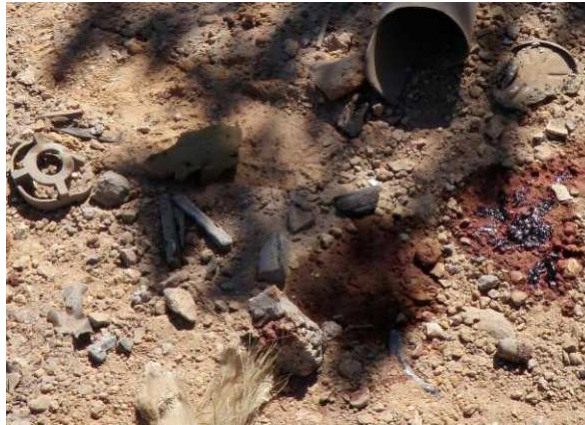
2) The investigators ignored the fact that the Victim of this accident had his leatherman multi-tool at the time. It appears in photographs amid the device debris, stained by blood, but the implication that it was in use at the time was not even considered in the report.

The concern about the susceptibility of the device to initiation by the faint electromagnetic influence of a stainless steel hand tool, his radio or cell phone was made much of. Designed to be initiated by the electrical influences from a large armoured vehicle, this was always extremely unlikely. Subsequent tests conducted by UK Government specialists appear to confirm this. The Demining group management interviewed by the DDAS researcher (shortly after the event) preferred this explanation to the more obvious conclusion that the Victim was deliberately interacting with the device. As the accident record shows, deliberate interaction is a common cause of severe injury and death among highly experienced international staff. Failure to recognise this is not likely to lead to controlling it.
